INTERIM TEST REPORT OF EXPLOSIVE EXPANSION  
INSTALLATION METHOD OF MAIN PROPULSION  
BOILER TUBES

NAVSSSES PROJECT B-0576

17 APRIL 1984

NAVAL SHIP SYSTEMS  
ENGINEERING STATION

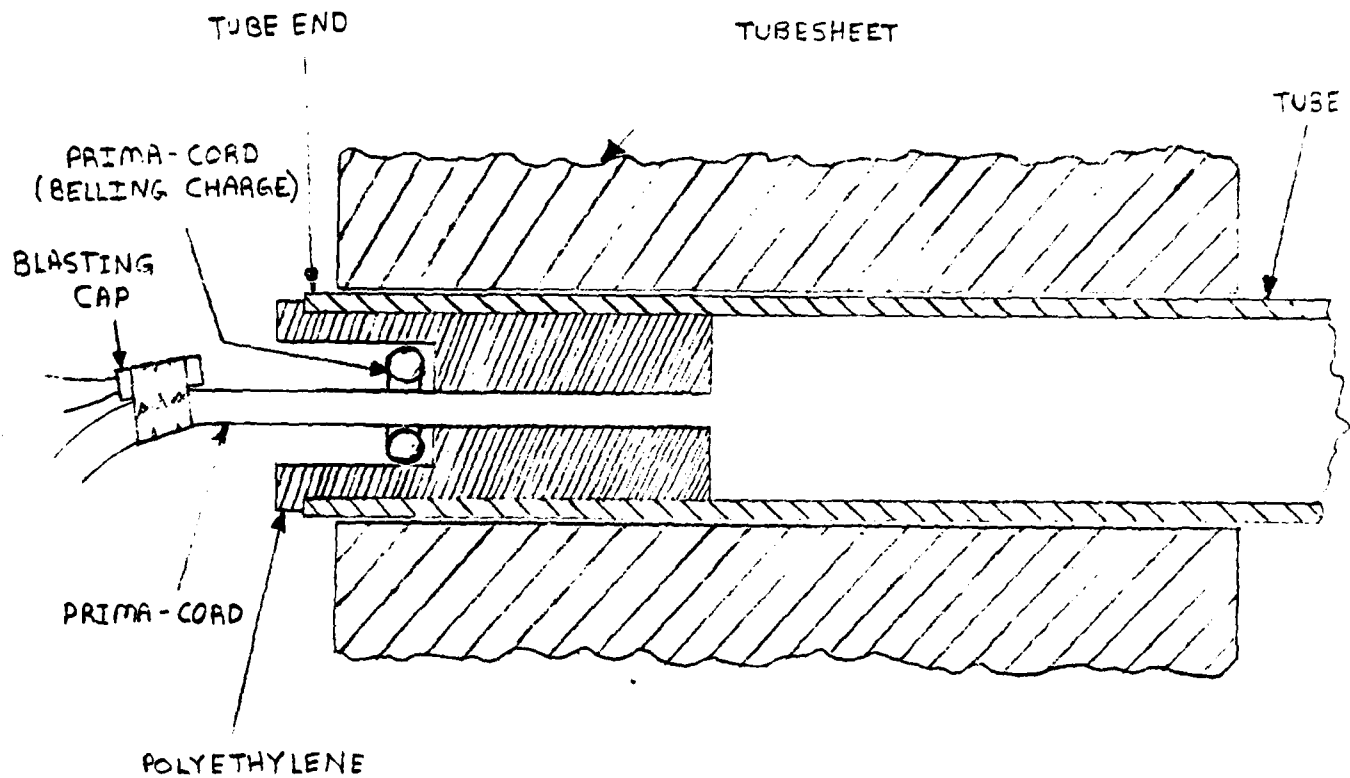
FIGURE 1

An explosive charge, comprised of a detonating cord encased in a polyethylene insert, is sized to fit the inside diameter of the tube within the depth of the tube sheet. The charge is inserted into the tube until a lip on the insert rests against the tube end. This lip locates the insert and prevents expansion of the tube beyond the tubesheet (see Figure 1).

EXPLOSIVE INSERT POSITIONED IN A TUBE  
AND TUBE SHEET ASSEMBLY
